## ***IMPORTANCE OF USING SEAT BELTS/BULLDOZER HIGHWALL ACCIDENT***

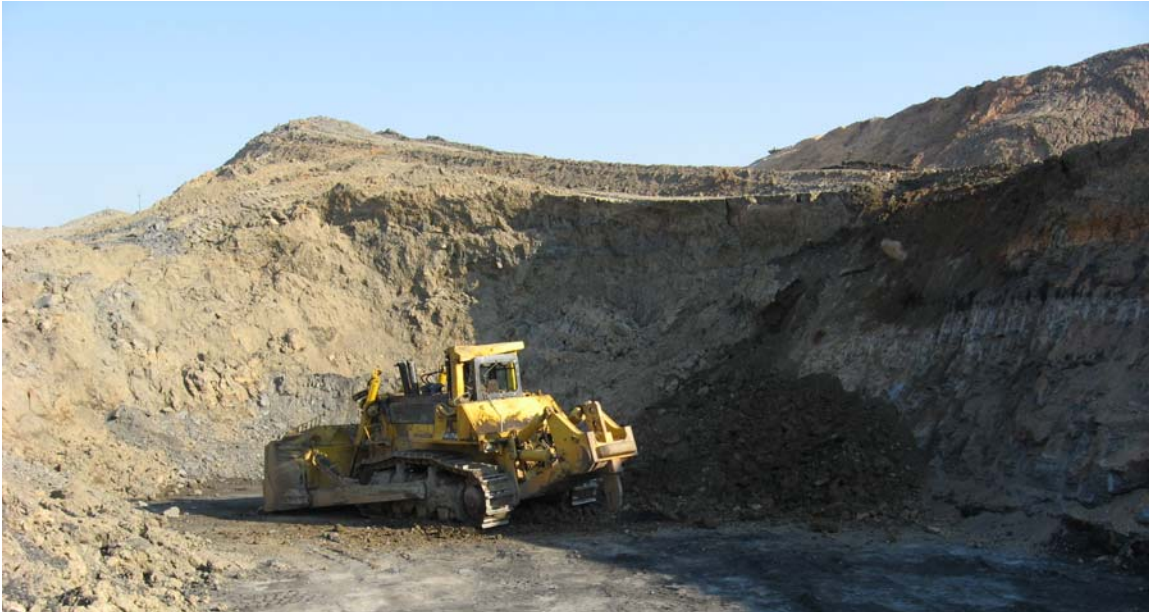
On March 19, 2007, a bulldozer operator, while pushing overburden, inadvertently ran the dozer over the edge of a highwall. The dozer slid over the approximately 34-ft highwall, rolled and landed upright on the pit floor. The operator exited the cab without assistance. He was hospitalized and held for observation. The investigation determined that the operator was wearing his seat belt.

1. Before work begins, travel and examine the perimeter of the highwall, checking for signs of instability.
2. Where possible, pushing operations should be conducted toward the highwall, remaining a set, safe distance from the edge.
3. Mark or reference the highwall edge and always maintain a safe distance from the highwall.
4. Always maintain adequate illumination when operating in low visibility situations.
5. Always wear the provided seat belt when operating mobile equipment.
